Veneer Visual Analyzer R5 - Scarf-Jointing

INCREASE END PRODUCT QUALITY WITH A HIGHER YIELD

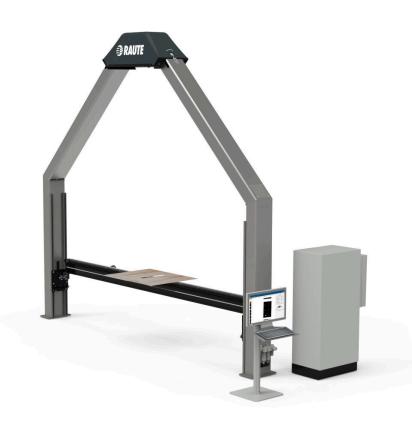
Veneer Visual Analyzer R5 - Scarf-jointing(formerly known as Mecano VDA Scarf-jointing) detects the defects and geometrical features of the veneer and controls the scarfing. It ensures that the veneer sheet is suitable for scarf-jointing: the dimensions are sufficient, and no pieces have come off during processing or transportation.
